Habitat Restoration Conducted at *ADARO* Grounding Site: Florida Keys National Marine Sanctuary

April 2004

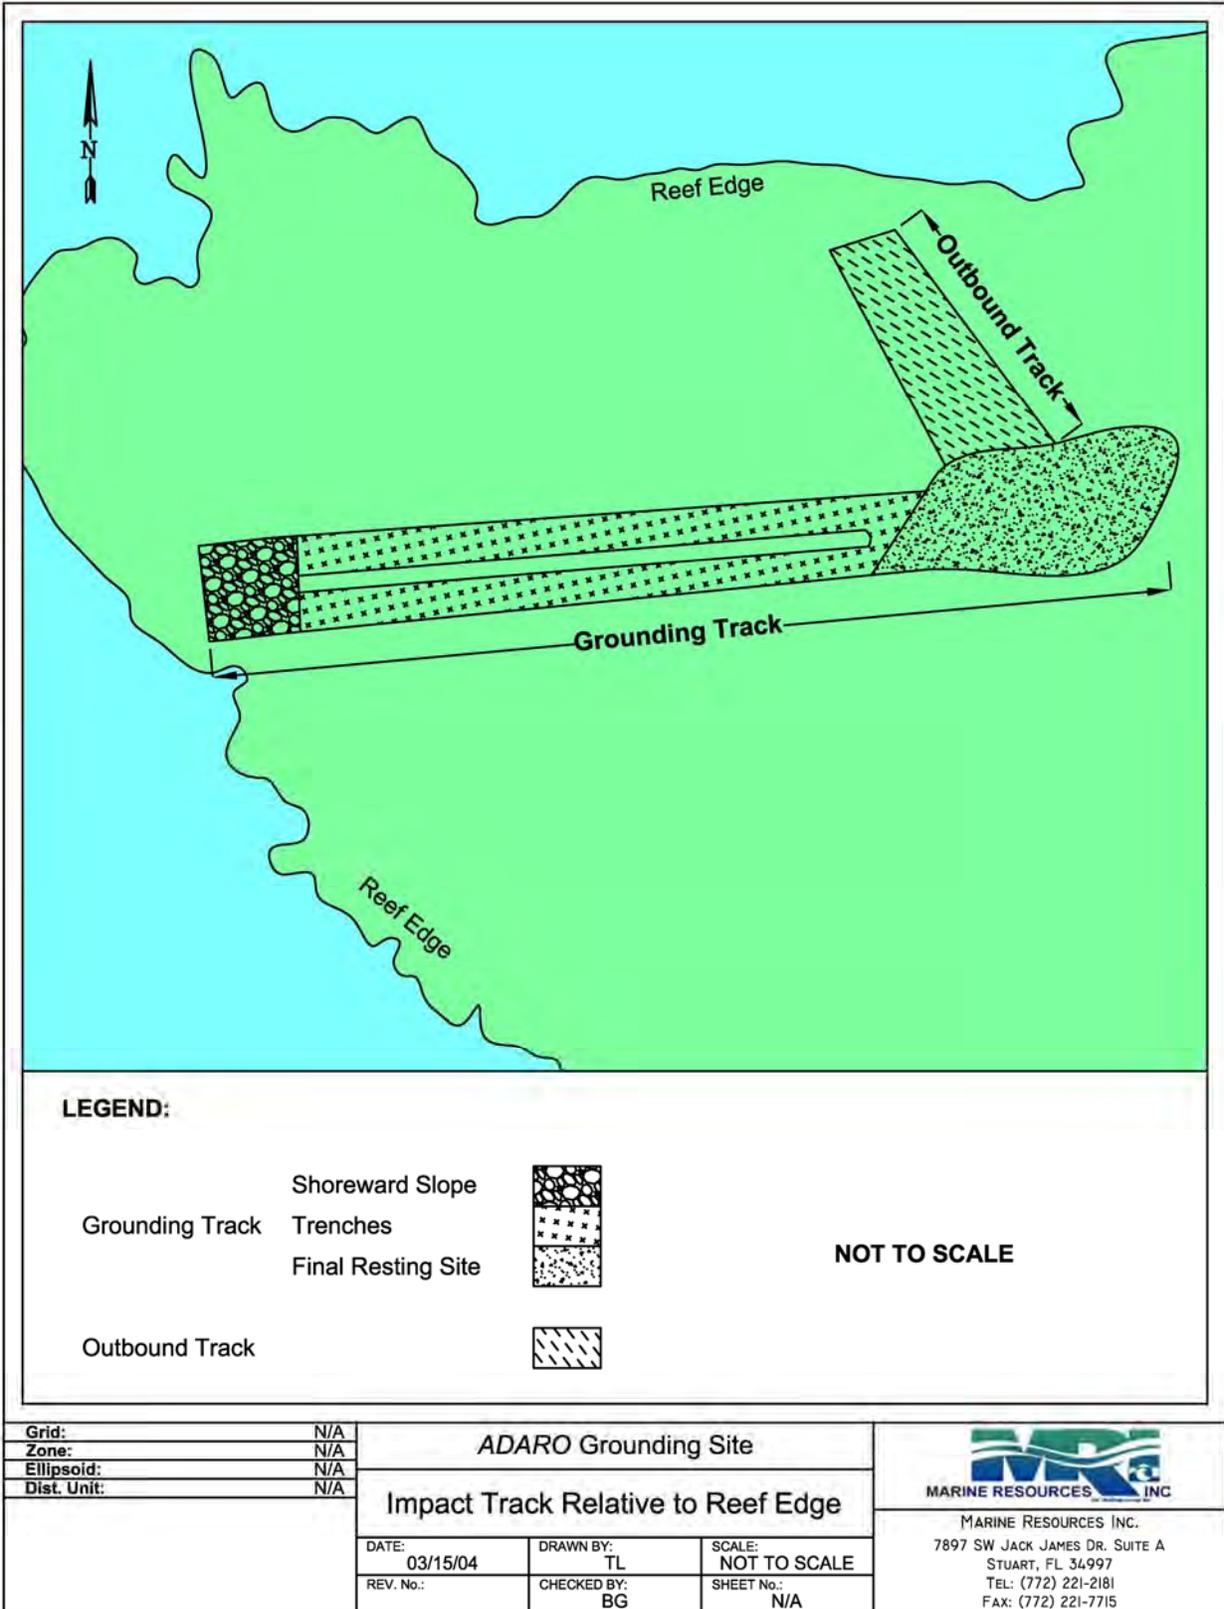
There are two distinct areas of impact associated with the grounding event which include the grounding and the outbound tracks (**Figure 2**). Impact along the grounding track was the result of vessel momentum. The grounding track is characterized by three zones of impact and are designated from shoreward to seaward (i.e., west to east) as 1) the shoreward slope, 2) trenches, and 3) final resting site (**Figure 2**). Noted impact along the shoreward slope was burial of epibiota and minor disruption of unconsolidated substrate. Shoreward slope impact was caused predominantly by framework rubble ejected behind the grounding vessel as it came in contact with the shallow reef crest along the trenches (i.e., seaward of the slope). The primary impact feature along the grounding track was the trenches formed by breaking, compressing, and displacing the structural framework of the reef crest (see **Image 3 Appendix**). The depth of the trenches below ambient grade was estimated to range from 0.3 to 1 m (1 to 3 ft). Impact at the final resting site of the grounded vessel was characterized by breakage and minor compression of a relatively thin surficial substrate overlying consolidated reef bedrock. Impact along the outbound track was the result of salvage operations and removal of the vessel from the final resting site following the grounding event. Impact along the outbound track was similar to impact observed at the final resting site.

Figure 2. Areas of impact associated with the *ADARO* grounding event.

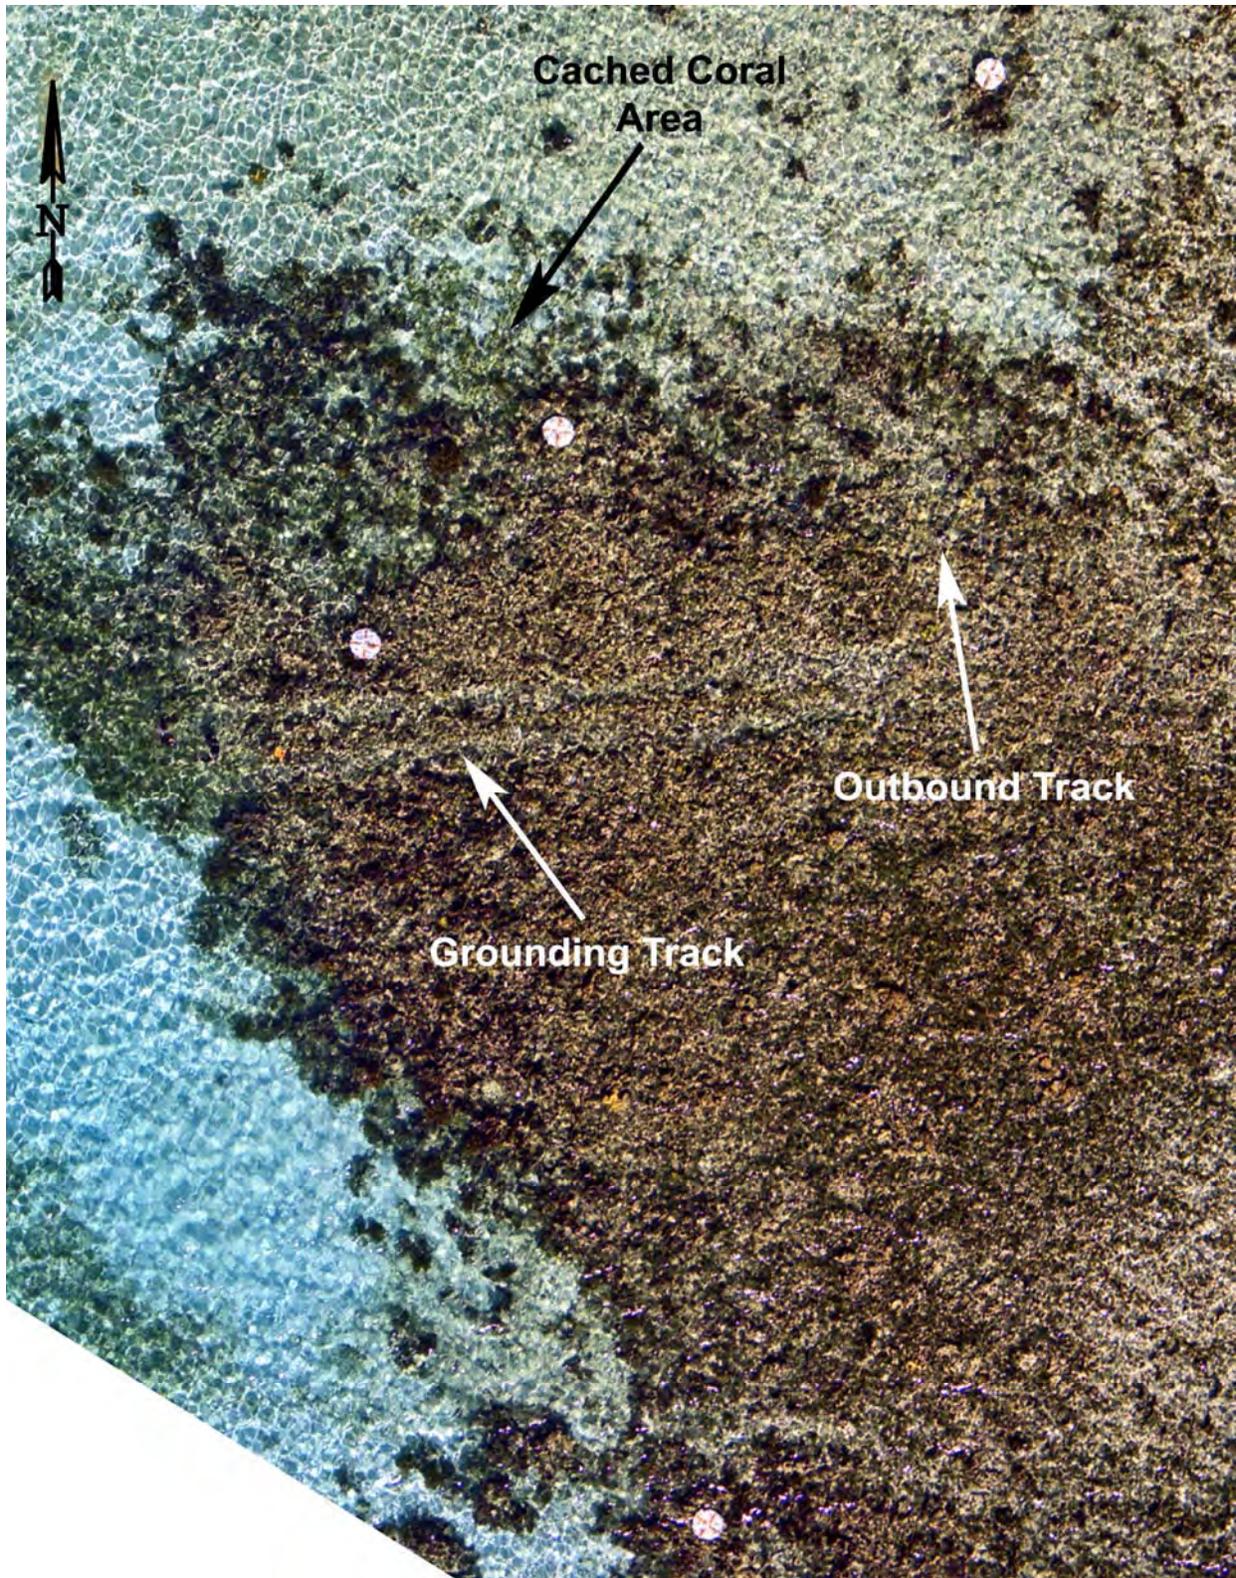
A representative aerial photograph of the grounding site and adjacent habitat showing the impact and cached coral areas is presented as **Figure 3**. Four on-bottom markers were deployed as visual targets (see **Figure 3**) and in conjunction with on-site permanent features (i.e., natural features of the habitat and man-made structures) should facilitate geo-rectification of aerial photographs. Navigational coordinates for each of the visual targets are listed in **Table 1**. Aerial photography was conducted 16 January 2004 during the early stages of primary restoration. Aerial photography provides visual data concerning the general conditions of the grounding/restoration site and adjacent habitat and could provide reference for detecting potential large-scale gross changes in the structural and biological condition of the restored habitat.

Figure 3. Representative aerial photograph of the grounding site and adjacent habitat showing the impact and cached coral areas and on-bottom markers utilized as visual targets.

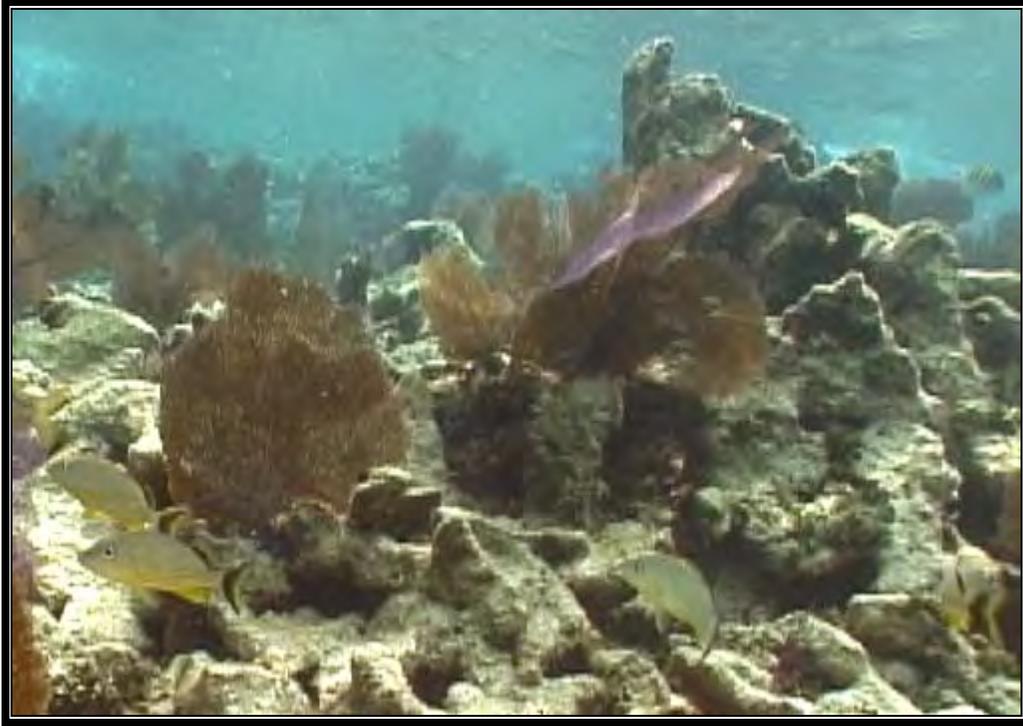
The impacted habitat is characterized as a moderately developed outer bank reef. The shallow-water reef crest is a relatively flat platform of dead and encrusted elkhorn coral (*Acropora palmata*) (see **Image 1 Appendix**). The structural framework of the reef crest is variably reticulated due to the settlement position of the branching elkhorn coral and density of lithified calcareous rubble/sediment within the internal voids. Visually dominant epibiota associated with the impacted reef crest are the mustard-hill coral (*Porites astreoides*) (see **Image 2 Appendix**), purple sea fan (*Gorgonia ventalina*), fire coral (*Millepora* spp.), white encrusting zoanthid (*Palythoa caribaeorum*), and sea rods (Plexauridae).

Image 1. The reef crest at the *ADARO* grounding site is a relatively flat platform of dead and encrusted elkhorn coral (*Acropora palmata*) with a veneer of attached biota.

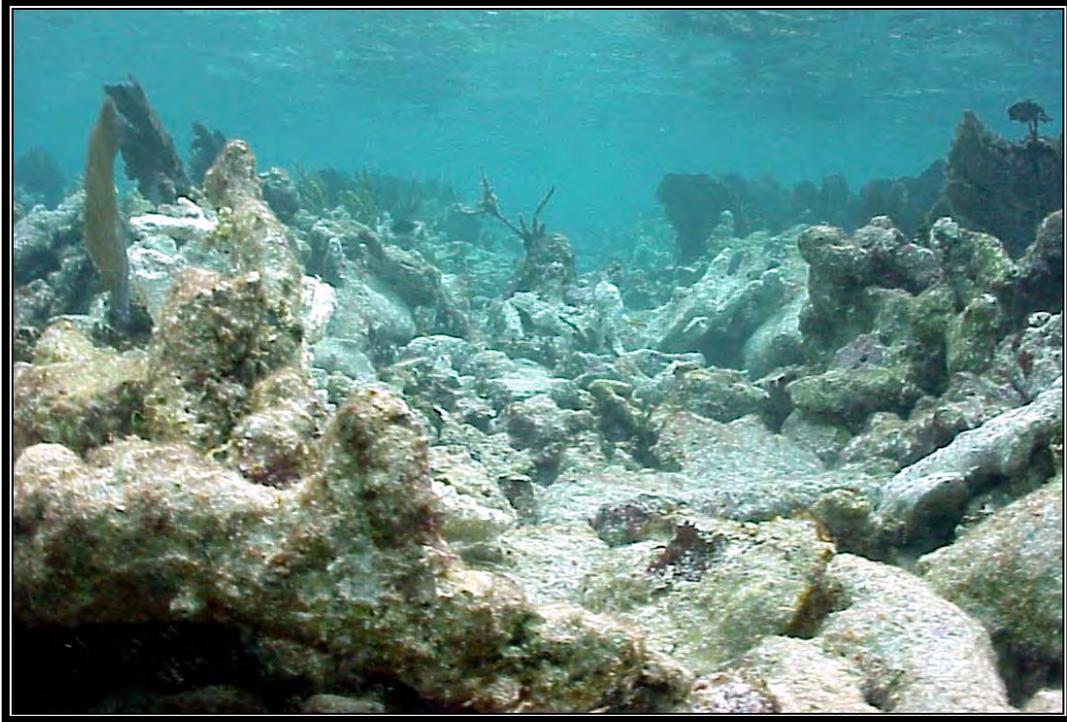
Image 3. Trenches were the primary impact feature of the *ADARO* grounding site.
