Coral Reef Ecosystem Restoration Work Group:

M/V Wellwood Grounding Site Restoration Case Study

Bill Goodwin
Sanctuary Resources Manager
FKNMS Coral Reef Ecosystem Restoration Work Group
Staff Support Lead

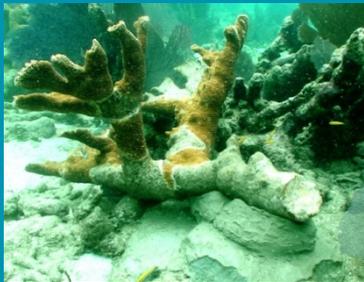
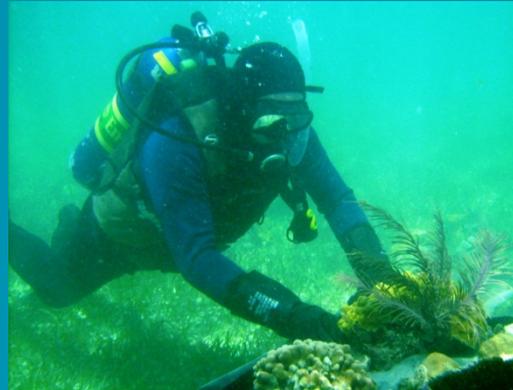
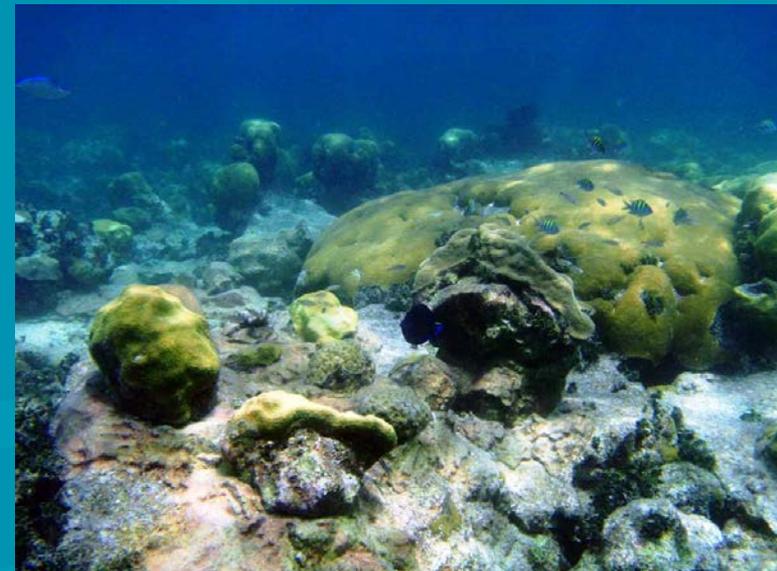
- August 4, 1984 – the *Wellwood*, a 122-meter (400-foot) freighter, ran aground on the upper forereef of Molasses Reef
- Water depth – approximately 6 meters
- Impacted over 75,000 m² of coral reef habitat
- Destroyed 5,805 m² of living corals

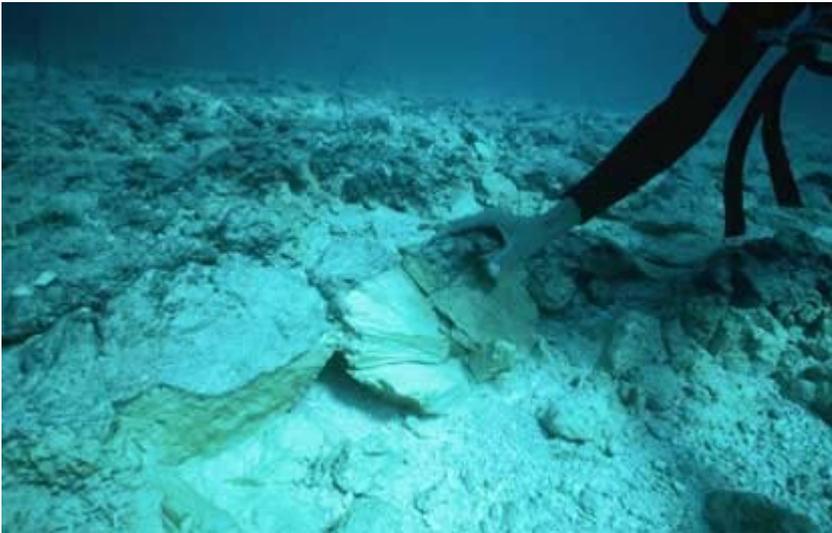
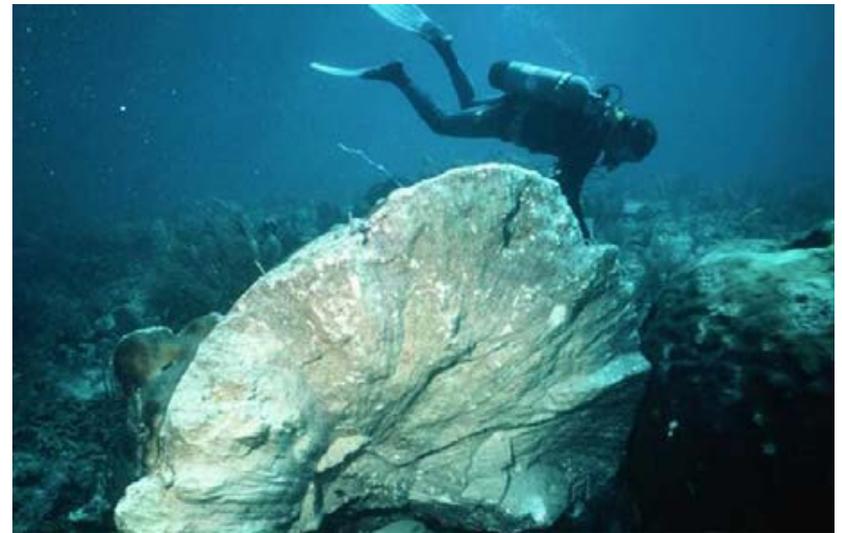
M/V *Wellwood* Restoration Site – Impacts to Molasses Reef

Injuries included:

- Breakage/dislodging of coral colonies
- Reef framework fracturing
- Bottom paint smears “burned” into reef substrate

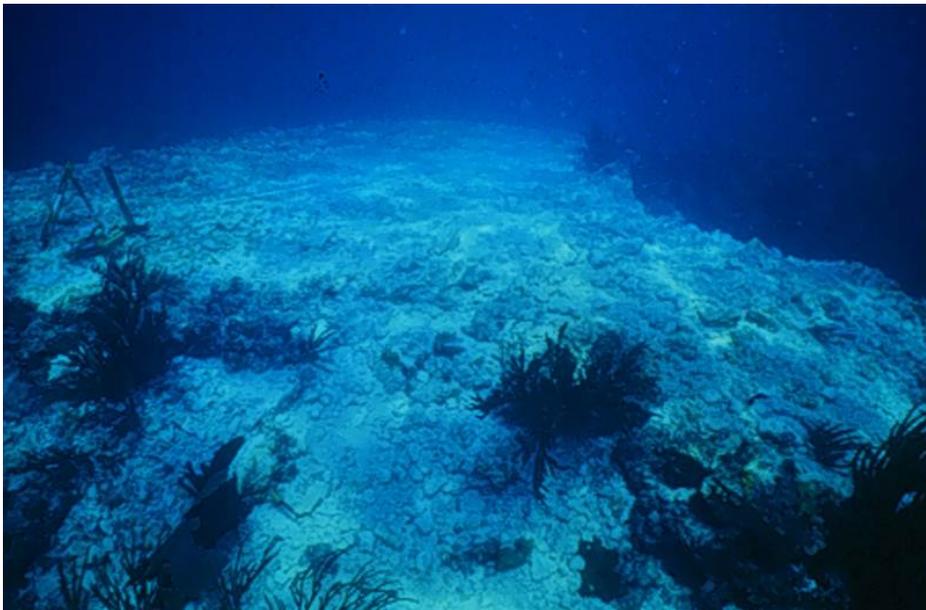
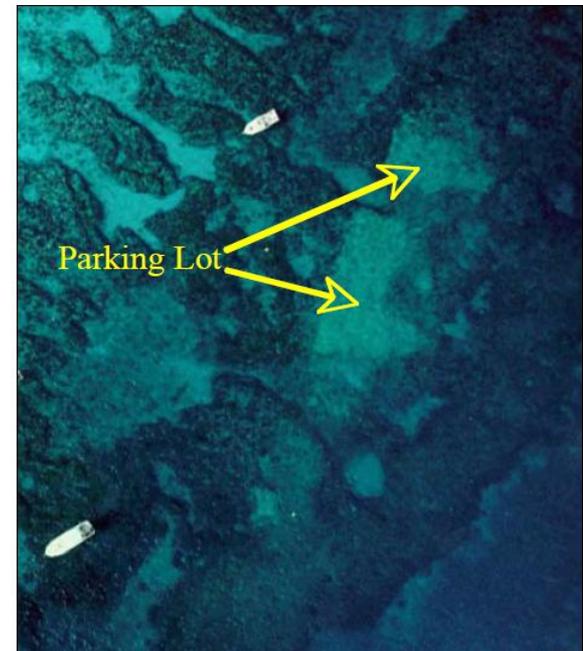
M/V *Wellwood* Restoration Site – Impacts to Molasses Reef

Injuries included:

- “Parking Lots” – areas of complete flattening and scarification of coral reef spur formations

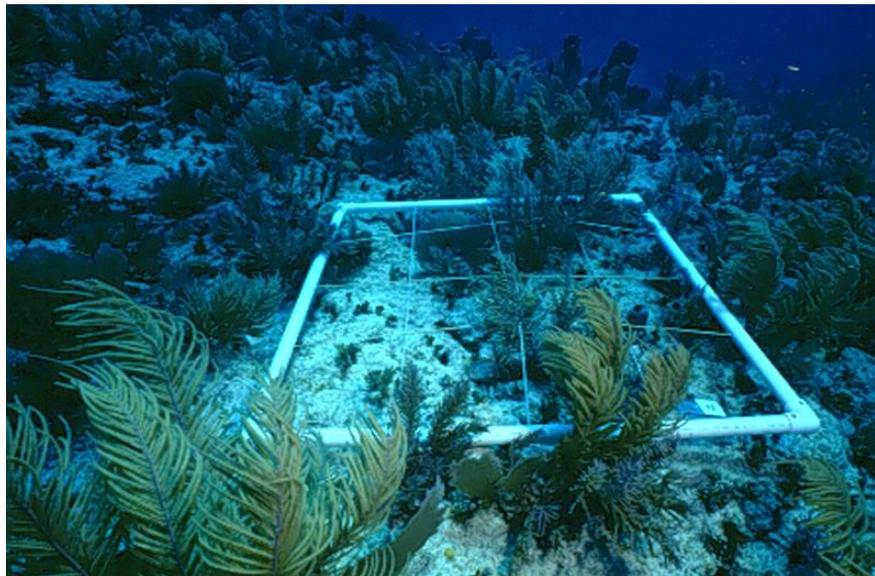
M/V *Wellwood* Restoration Site – Slow Natural Recovery

- a decade after the grounding incident, the grounding site had become a “prairie” of octocorals, juvenile hard corals, sponges and macro algae
- structurally and ecologically, much more like a livebottom or hardground than a coral reef

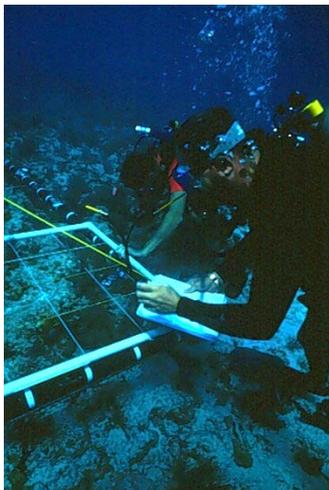
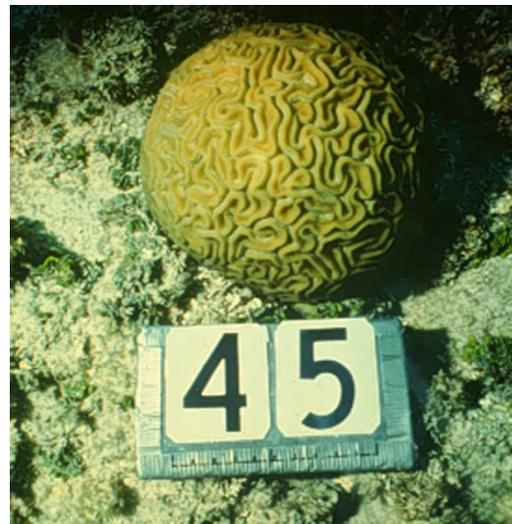
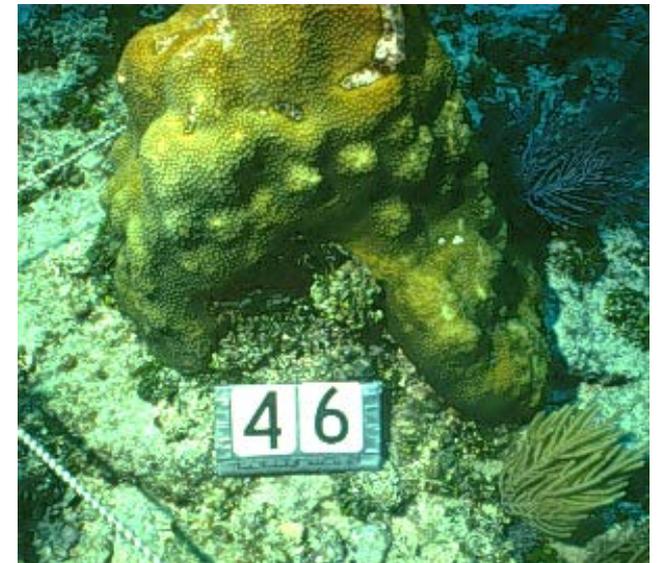
M/V *Wellwood* Restoration Site – Slow Natural Recovery

Wellwood site survey - June/July 1994

- over 500 natural hard coral recruits, all < 10 cm
- 90% survival of original transplants
- however, Hurricanes Mitch, Georges and Irene ('98/'99) essentially set clock back to zero.

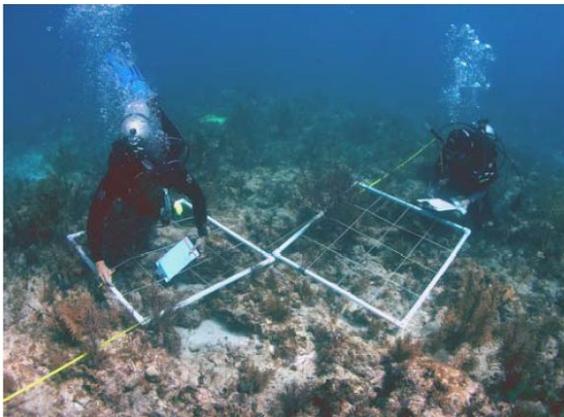
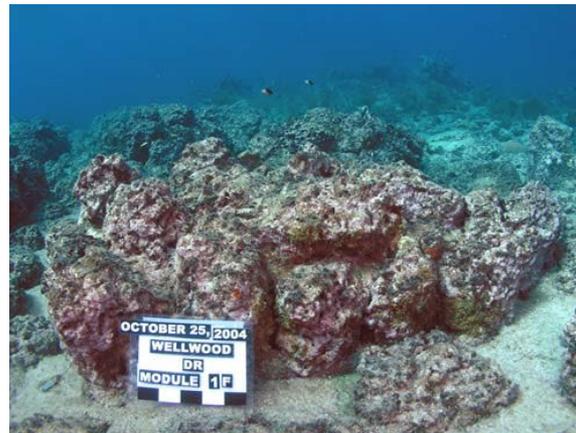
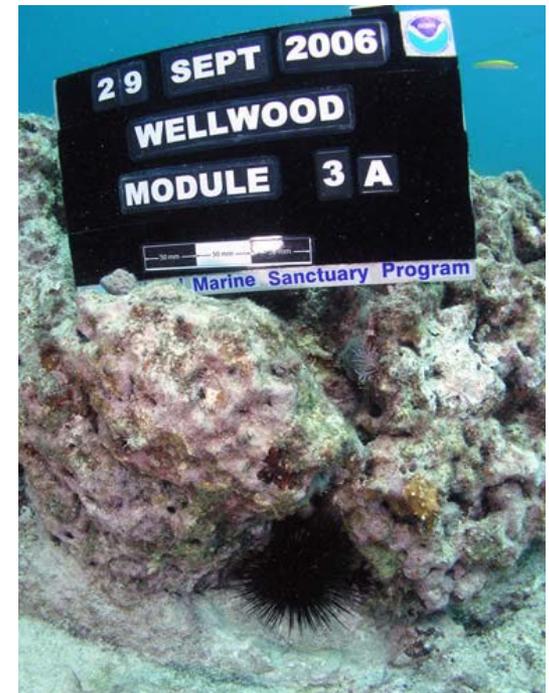
M/V *Wellwood* Restoration Site – Monitoring Program

Restoration monitoring

- visual inspection/survey
- high resolution photo-quadrats
- monitoring included restored, unrestored and adjacent non-impacted reference areas

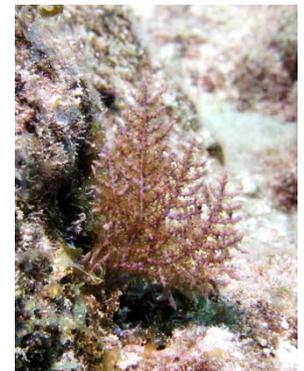
- macro algae, coralline algae, soft, and hard corals were all recruiting to the restoration modules and surrounding concrete puddle pour areas
- by 2006, the restored area was converging on the recruitment state of the unrestored and reference areas
- settlers seem to prefer limestone rock, rather than concrete, as substrate
- restored areas had a greater proportion of all taxa populations in the smallest size category

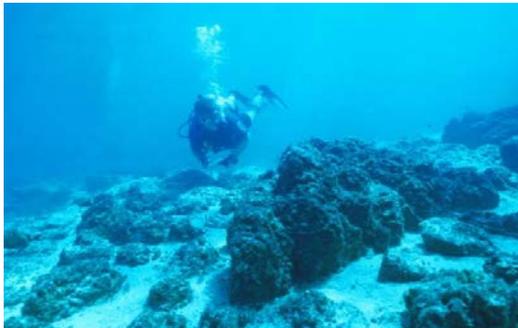
October, 2002

Reef Environmental Education Foundation (REEF) fish assemblage monitoring at the *M/V Wellwood* grounding restoration site

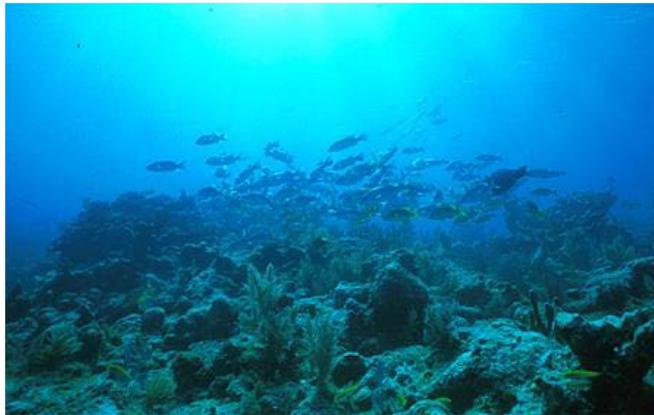
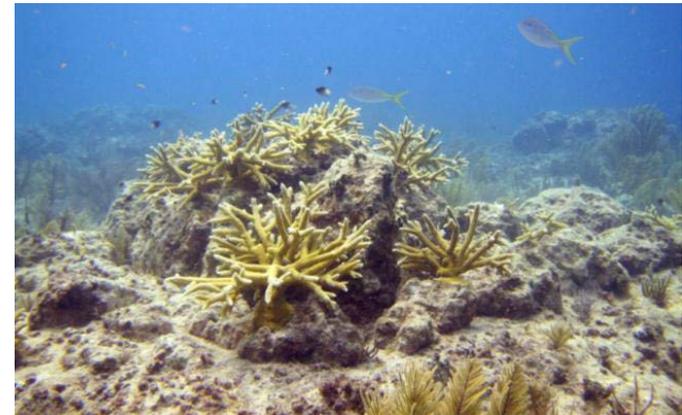
- overall fish diversity as well as density and biomass of most key fish families on restored site continue remained less than that of the two nearby, non-impacted reefs
- parrotfish and surgeonfish population responded the most quickly to restoration efforts
- as CRF-produced *A. cervicornis* transplants grow on the higher relief modules, apparently so do the numbers of fish species congregating on these modules
