***M/V WELLWOOD***  
**Coral Reef Restoration Monitoring Report**  
**Monitoring Events 2004-2006**  
**Florida Keys National Marine Sanctuary**  
**Monroe County, Florida**

April 2007

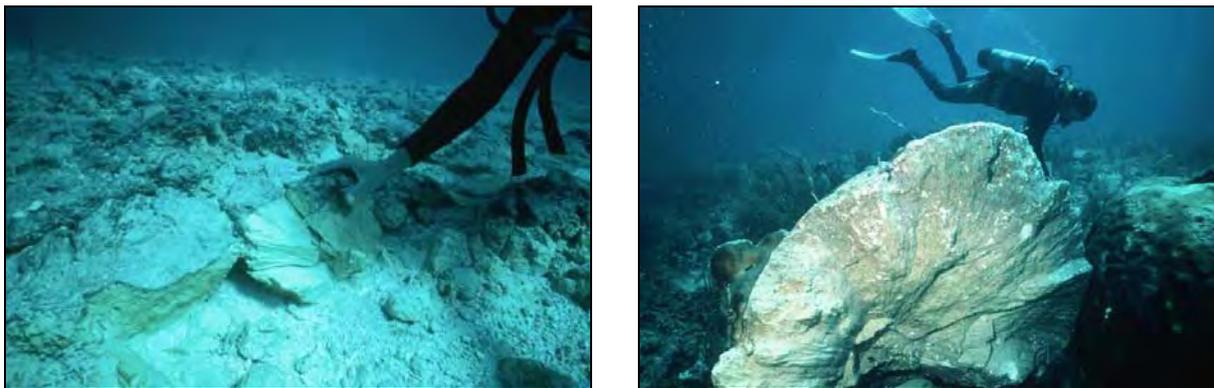
**Figure 2.** Fractured reef substrate (left) and split *Montastraea faveolata* colony (right) resulting from the M/V *Wellwood* grounding (photo credit: FKNMS).

As the vessel approached the reef, it created an inbound grounding track approximately 20 m wide and affected bottom substrate up to 6 m deep. The injury toppled or injured 13 large coral heads and left bottom paint embedded in exposed coral skeletons.

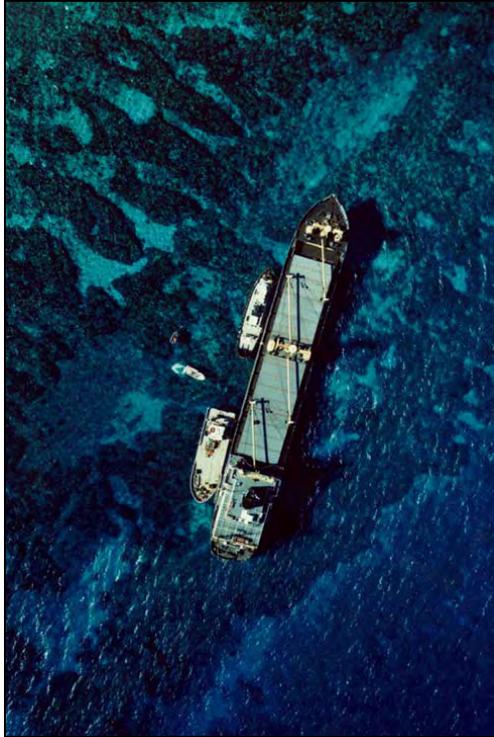
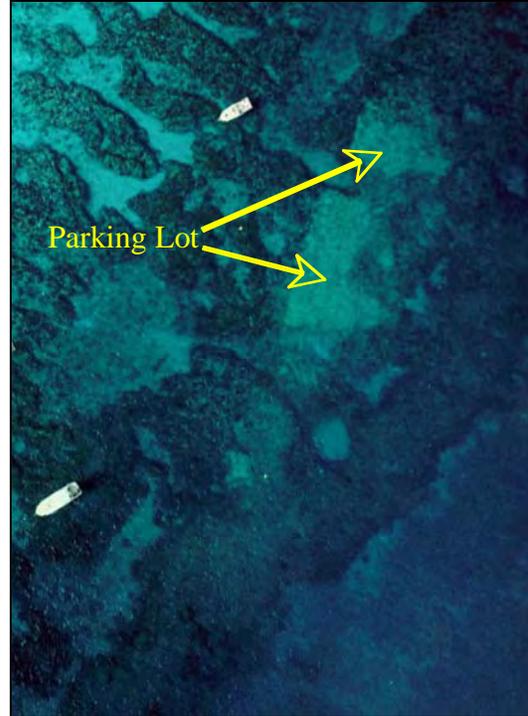
Along the starboard side of the hull resting site there was an extensive area that experienced patchy areas of destruction. This was the original resting area of the vessel before it pivoted during initial removal attempts. At least 6 large boulder coral colonies and numerous smaller organisms were destroyed as the vessel scraped the bottom.

**Figure 3.** Aerial view of M/V *Wellwood* aground on Molasses Reef (left) and “parking lot” area after removal (right).

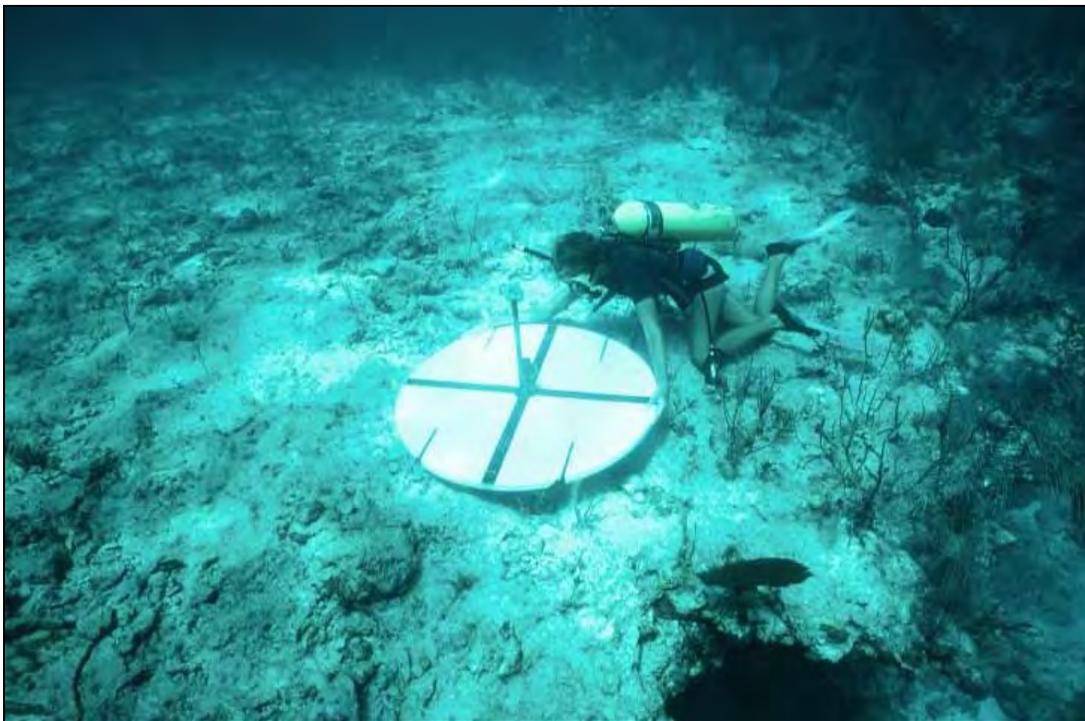
**Figure 4.** Diver installing reference marker in the “parking lot” for geo-referencing aerial photography (photo credit: FKNMS).

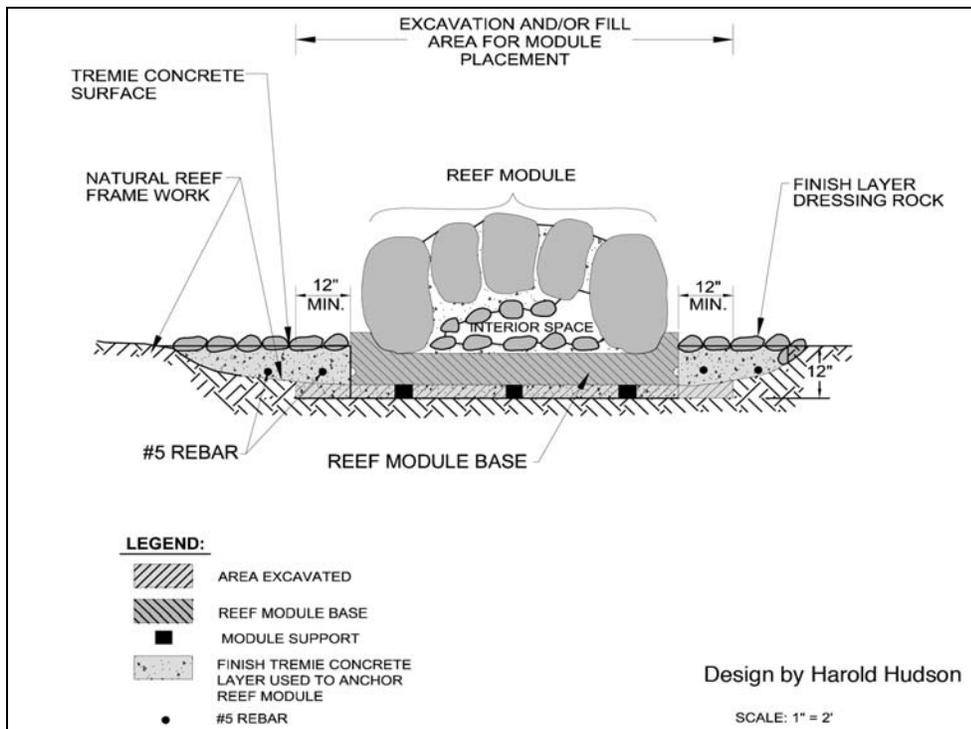
The objectives of the M/V *Wellwood* site restoration were to 1) stabilize damaged reef framework, 2) infill hurricane-excavated craters, and 3) rebuild reef topography. To accomplish these objectives, a design concept featuring artificial reef modules was developed (Figure 6). The artificial reef modules were designed and constructed by Harold Hudson, reef restoration biologist of the Florida Keys National Marine Sanctuary. The artificial reef modules closely replicated the adjacent undamaged reef, rebuilding reef topography that had been lost as a result of the *Wellwood* grounding. Modules were five-sided (from a planar view) with an approximate height of 1.2 m (4 ft), length of 1.8 m (6 ft), and a width of 1.5 m (5 ft). Damp sand was placed inside the form during the fabrication process to create a 30 cm (12 in) high reef cave within the structure (Hudson and Franklin 2005). The hollow interior of each module provided space to be used by fish and sessile organisms, and the rough limestone provided habitat for organisms using interstitial spaces or for boring organisms. The modules minimized the concrete surface exposure and maximized the exposure of limestone surfaces, enhancing the environmental features of the module design.

**Figure 6.** Cross section of installed reef restoration module.

The reef restoration design consisted of the placement of 22 reef modules and/or limestone boulders, stabilized with a tremie pour of concrete within the 14 repair sites depicted in Figure 7. An aluminum frame outline of the reef module, which was constructed by NOAA, was used to determine the exact location, orientation and accurate leveling of each reef module prior to placement at the repair site. Reef module placement was contingent upon placement of the modules in natural and/or excavated receiver sites, allowing tremie pour concrete to secure the module to the reef. Excavation of the existing rock substrate was often conducted to provide the appropriate receiver site for module placement. Each module was placed on 2-inch to 4-inch supports to allow concrete to flow under the module, in addition to providing a minimum 12-inch wide and deep apron entirely around each module (Figure 8). After the reef module was placed, concrete was tremie poured within the excavated depression, cementing the reef module into the existing reef substrate. A total of 9 repair sites received reef modules.

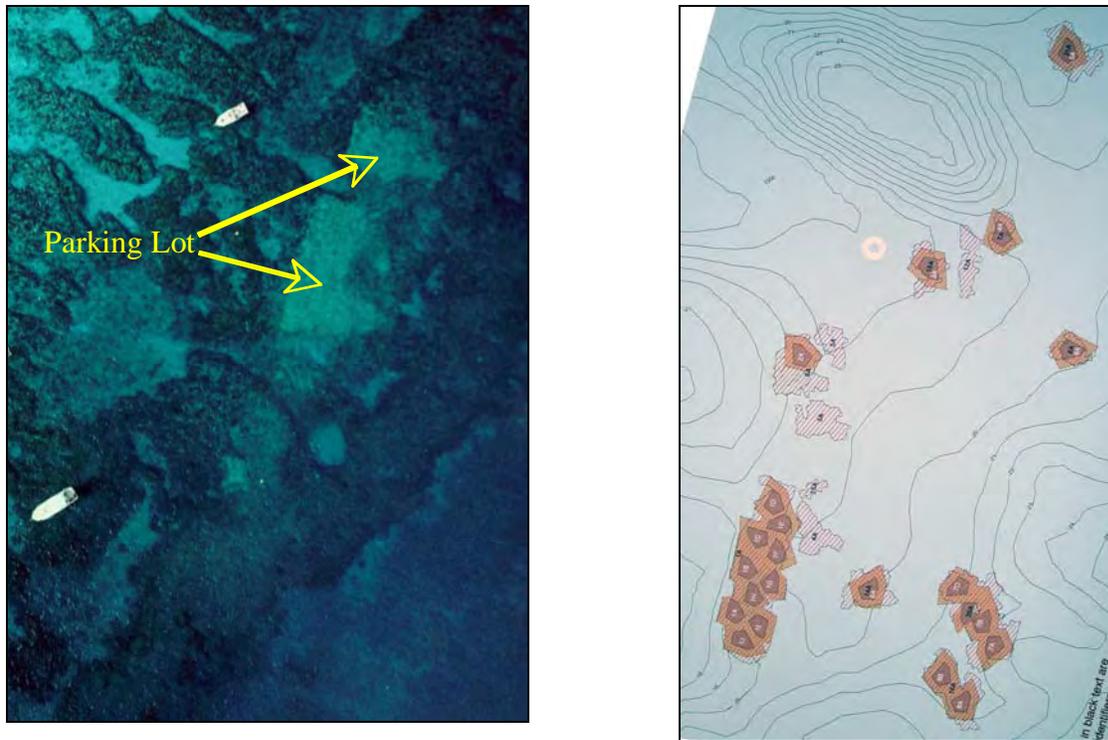
The remaining 5 sites were determined to be too small and/or shallow to accommodate reef restoration modules. At these sites, a combination of 1-2 ton limestone boulders and tremie poured concrete, referred to as a “puddle pour,” were used to fill the excavation. Limestone rock dressing stones, 25-45 cm (10-18 in) in diameter were pressed into the fresh concrete at close intervals to increase rugosity and provide a more natural substrate. The concrete embedded boulders projected 50-100 cm (20-40 in) above the dressing stones in all “puddle pour”

**Figure 7.** Aerial photograph of “parking lot” damage caused by the M/V *Wellwood* grounding (left) and a bathymetric map depicting locations of reef restoration modules (shaded in brown) and “puddle pour” restoration areas (right).

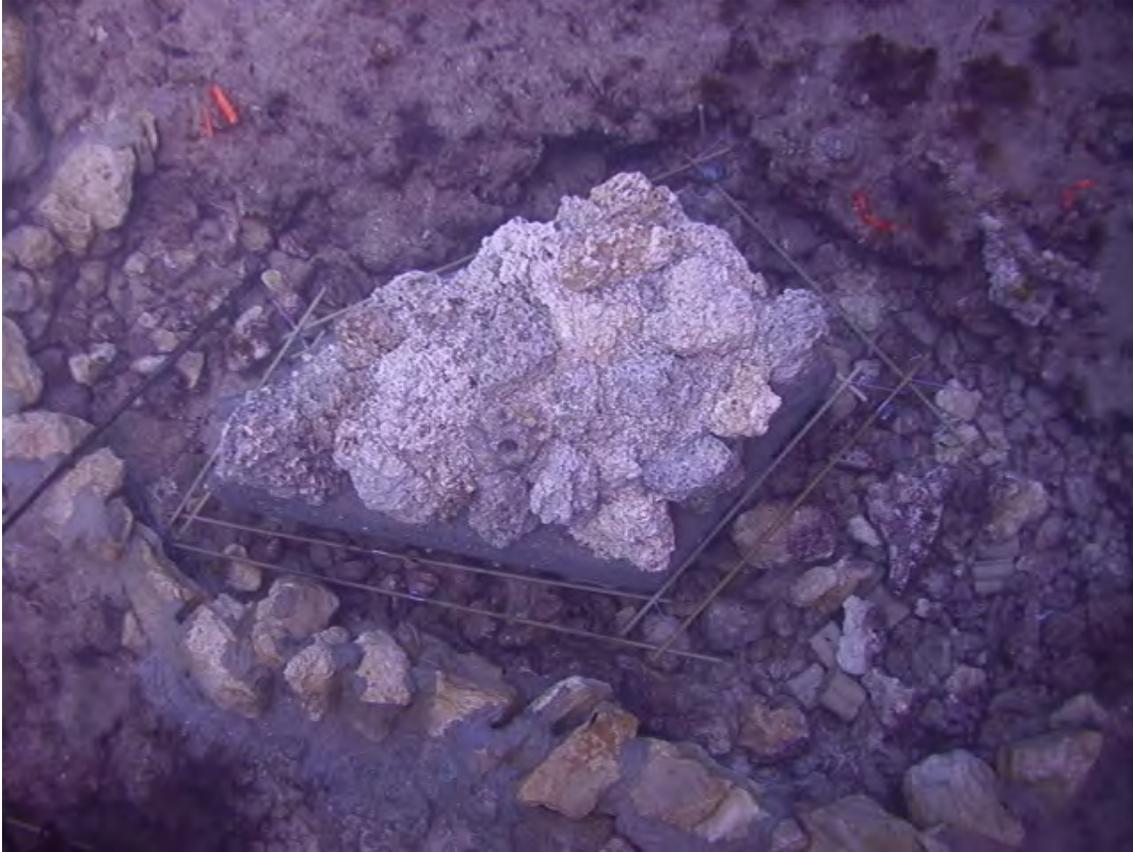
**Figure 8.** Reef restoration module and reinforcing rods in excavation crater ready to accept tremie pour concrete (photo credit: FKNMS).

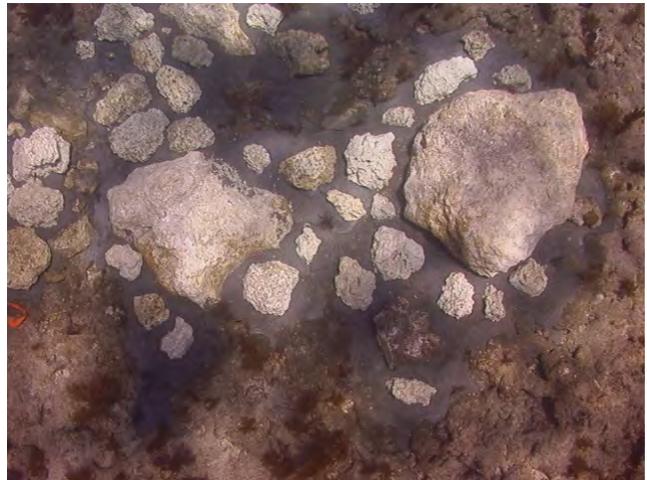
applications (Hudson and Franklin 2005). A total of 185 m<sup>2</sup> of damaged reef substrate was repaired using these 2 restoration techniques (Figure 9).

**Figure 9.** Completed restoration with reef restoration modules (left) and “puddle pour” with boulders (right) each surrounded by limestone “dressing” stones (photo credit: Coastal Planning and Engineering, Inc.).

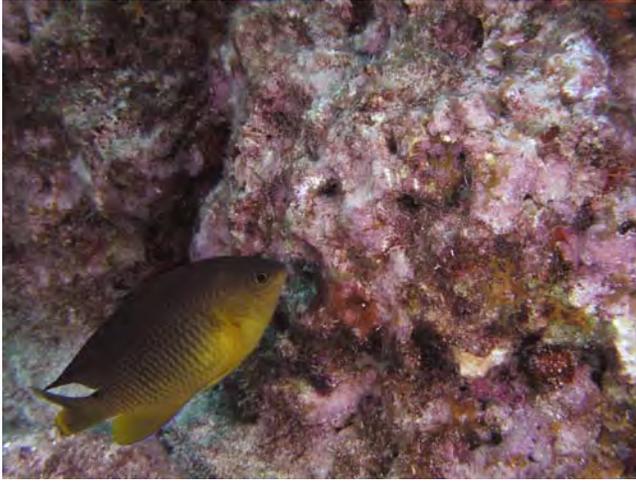
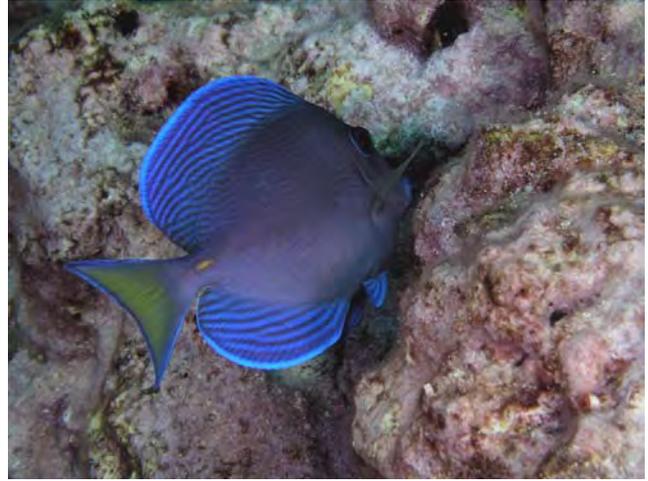
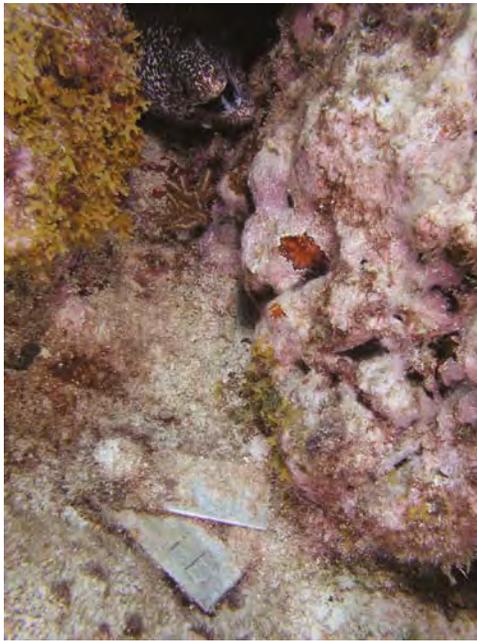
**Figure 11.** Fauna living in and around reef restoration modules. Starting from upper left: cocoa damselfish (*Stegastes variabilis*), blue tang (*Acanthurus coeruleus*), spotted moray eel (*Gymnothorax moringa*), long-spined urchin (*Diadema antillarum*), and Pederson cleaner shrimp in corkscrew anemone (*Periclimenes pedersoni* in *Bartholomea annulata*) (photo credit: Jeff Anderson).

Although not included in rigorous statistical analysis, numerous vagile fauna were observed on, in, and around the restoration modules (Figure 11). This was undoubtedly due to both the benthic organisms already colonizing the module structures, as well as the shelter afforded by the cave intentionally designed within the modules (Figure 6).

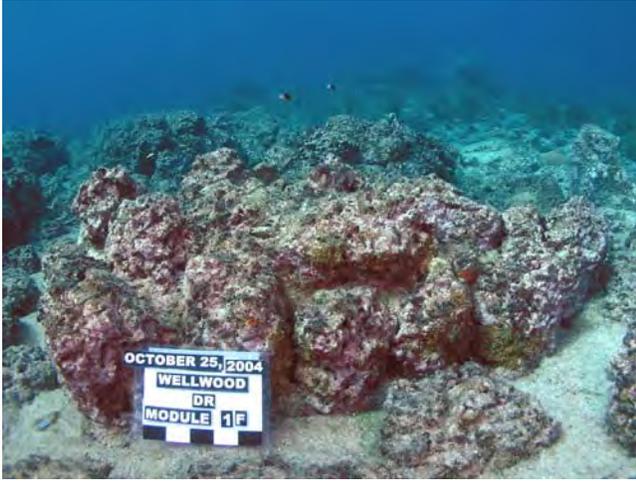
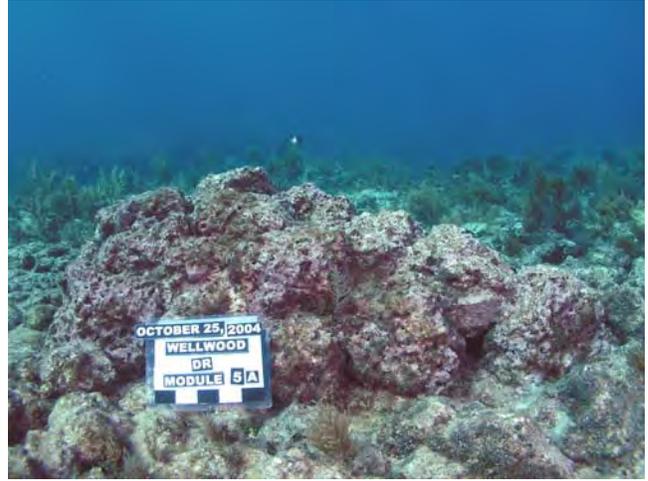
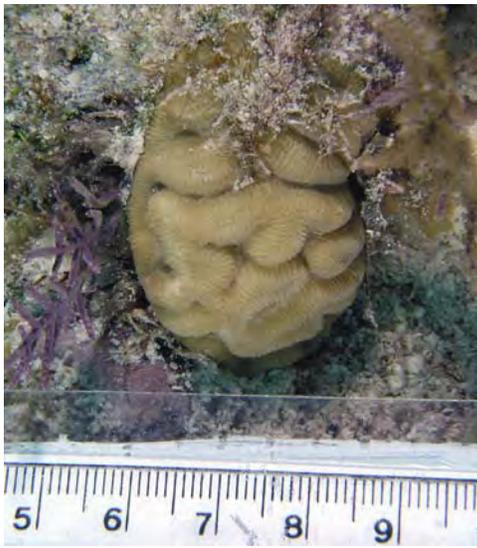
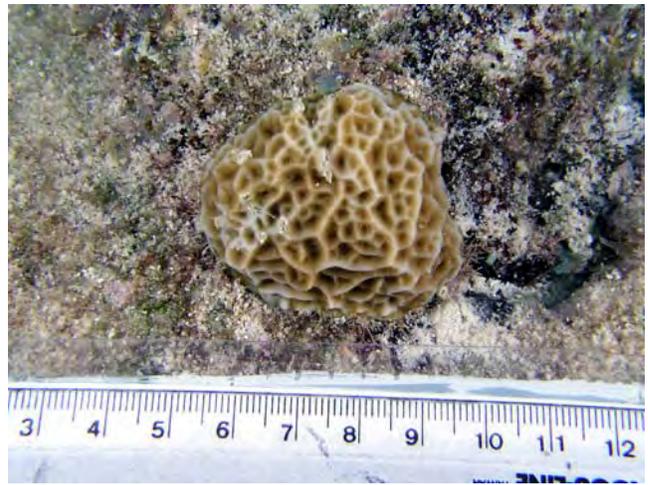
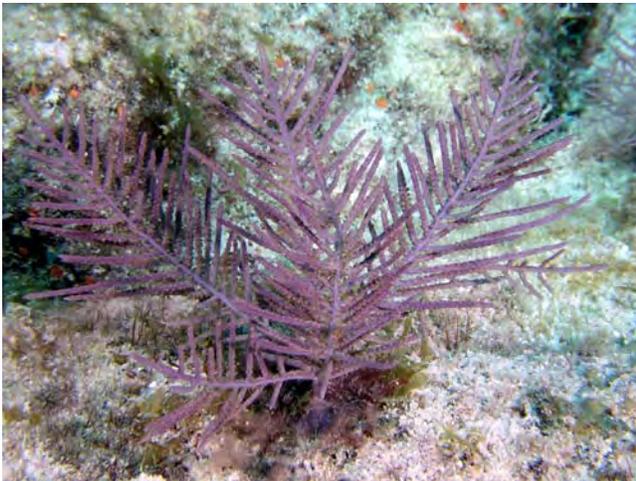
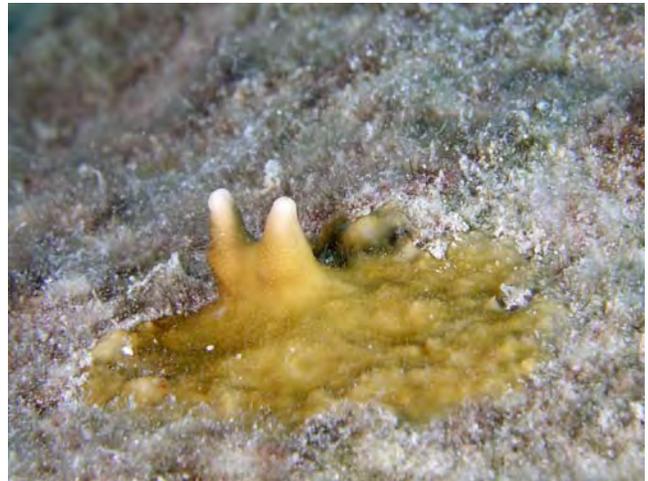
The preliminary monitoring occurred 2 years after the restoration, at which time the stability and surface of all 22 restoration modules and puddle pour areas were found to be visually and tactilely sound. The modules were found in place with a stable attachment to the substrate and no visible cracks in the cement surface. As part of an unrelated project, *Acropora cervicornis* fragments were attached to module 6A in restoration area 8A. There was no noticeable physical damage to the reattached coral fragments and these colonies were not included in the analyses which follow.

The biological condition of the restoration site was progressing. Macro algae, crustose coralline algae, soft, and hard corals were all recruiting to the restoration modules and surrounding concrete puddle pour areas (Figure 12). For photographs of all 22 restoration modules, please see APPENDIX 2.

**Figure 12.** Restoration modules showing biological condition 2 years after installation along with close-up photos of representative benthic organisms surveyed. Starting from middle left: *Diploria labyrinthiformis*, *Agaricia* sp., *Pseudopterogorgia* sp., and *Millepora* sp. (photo credit: Jeff Anderson).

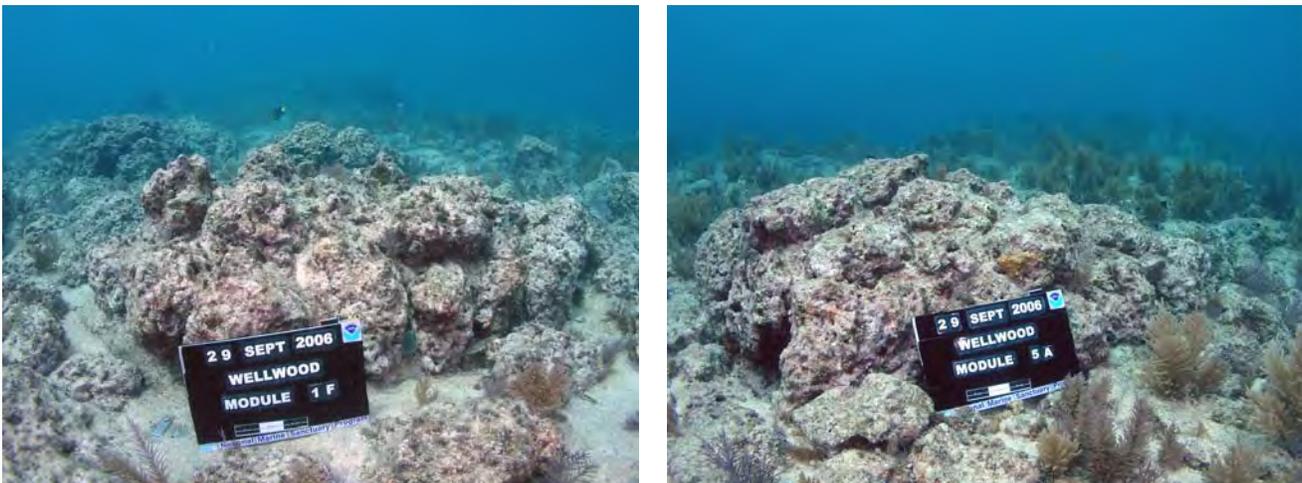
Despite the near passage of 4 hurricanes during the 2005 storm season, the stability and surface of all 22 reef restoration modules and puddle pour areas were again found to be visually and tactilely sound.

The biological condition of the restoration site continued to progress. Macro algae, crustose coralline algae, soft, and hard corals were all still present on the restoration modules and surrounding concrete puddle pour areas (Figure 20). For photographs of all 22 restoration modules, please see APPENDIX 2.

**Figure 20.** Restoration modules showing biological condition 4 years after installation (photo credit: Jeff Anderson). Compare to the same 2 modules shown in Figure 12.

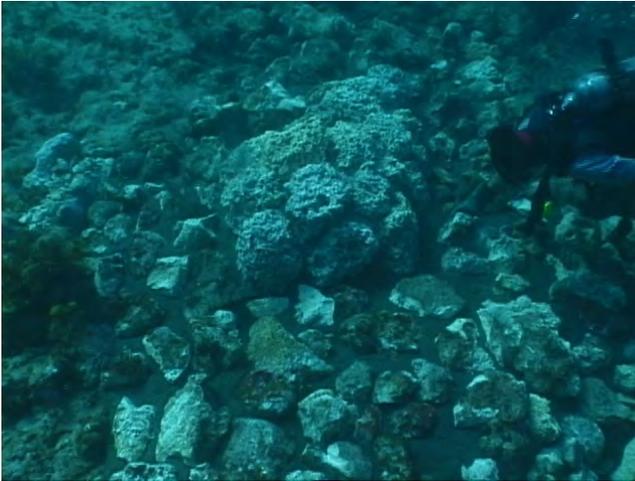
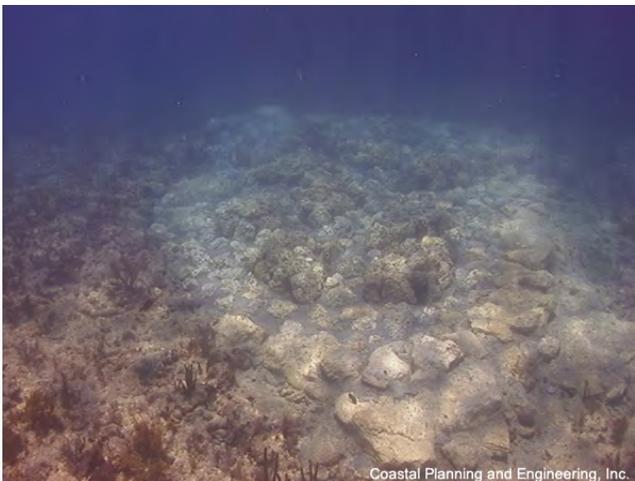
## APPENDIX 1

Photographs of completed reef restoration module and puddle pour installations from June-July 2002  
(photo credits: Florida Keys National Marine Sanctuary and Coastal Planning and Engineering, Inc.).

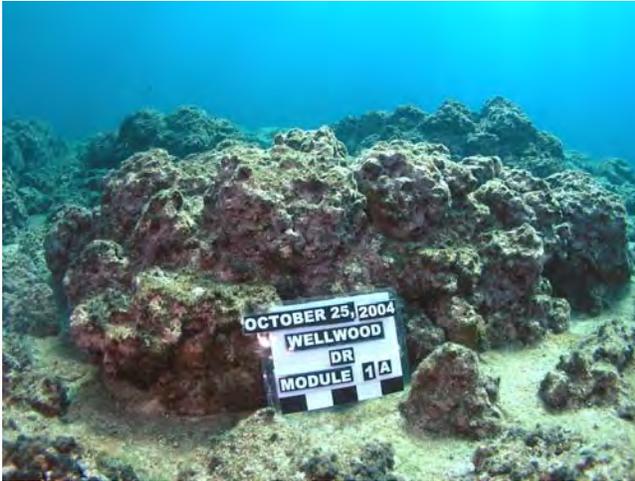
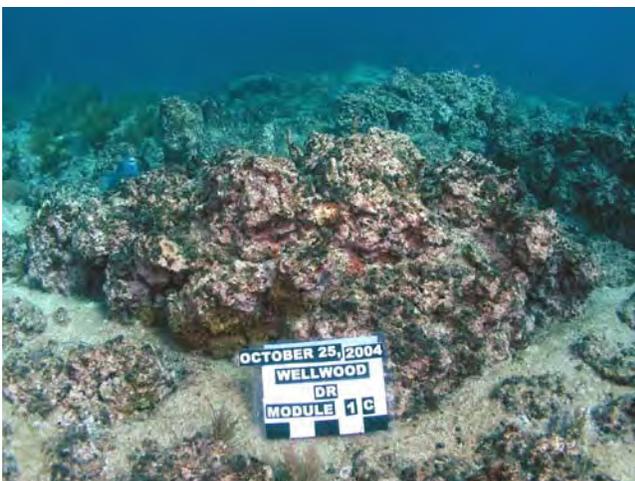
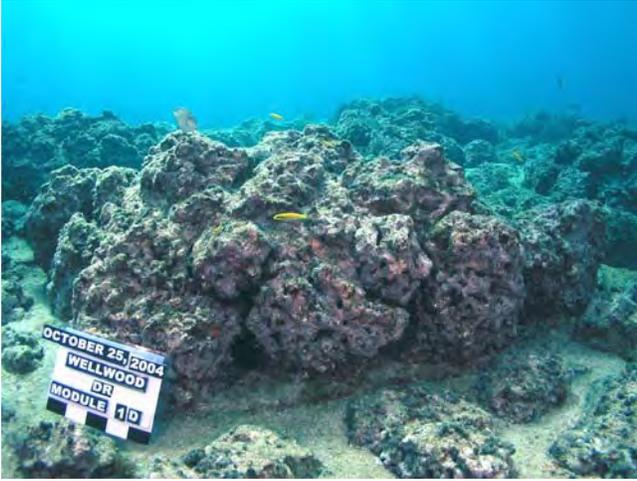
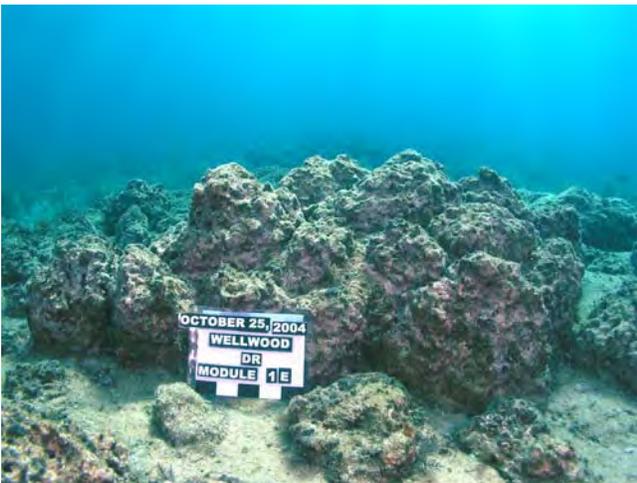
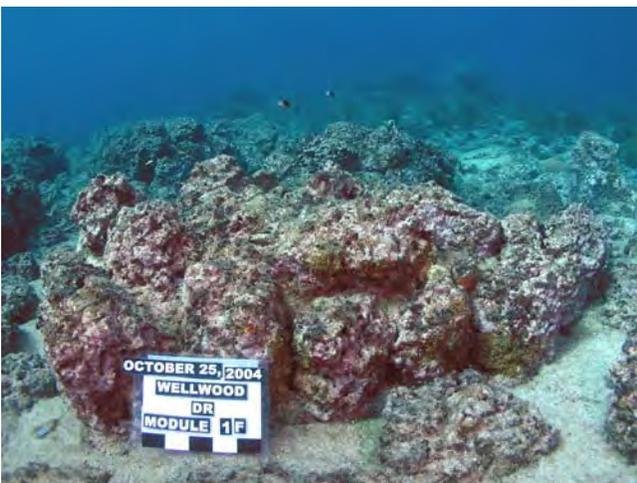
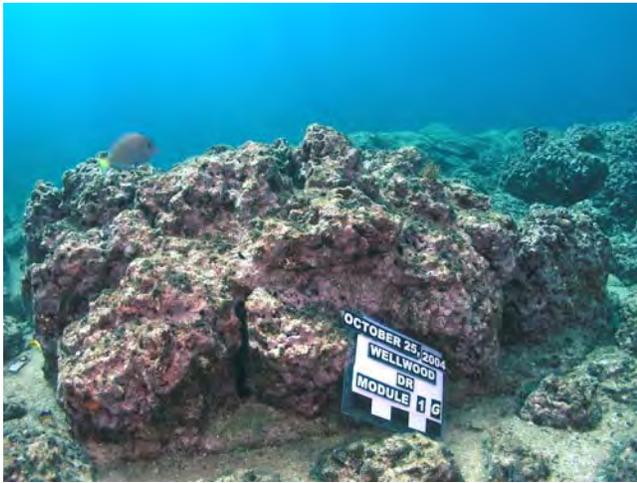
## APPENDIX 2

Comparative photographs of reef restoration modules from October 2004 (left) and September 2006 (right) (photo credits: Jeff Anderson).

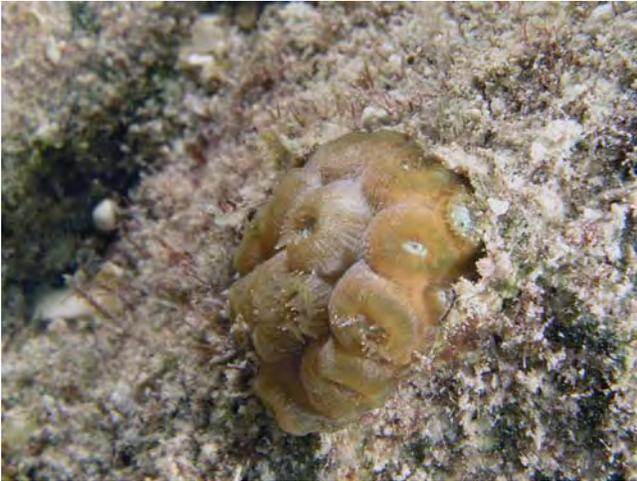
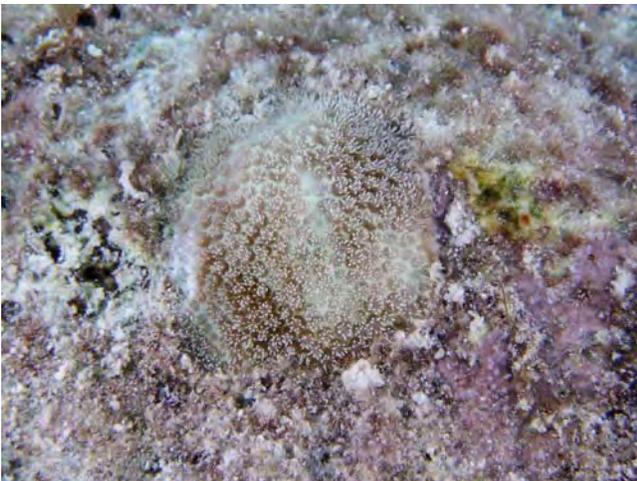
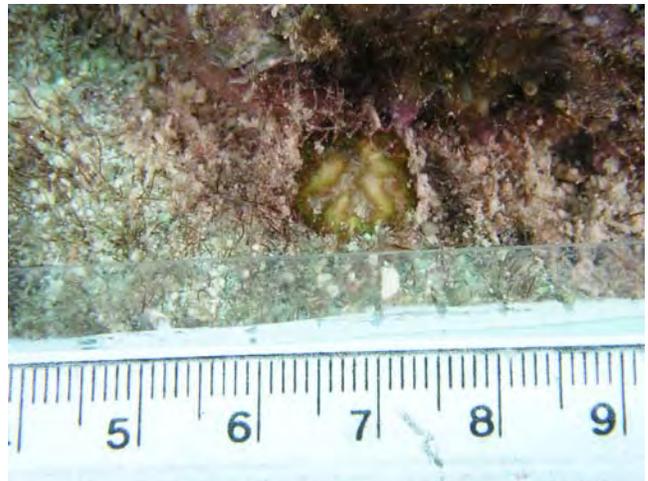
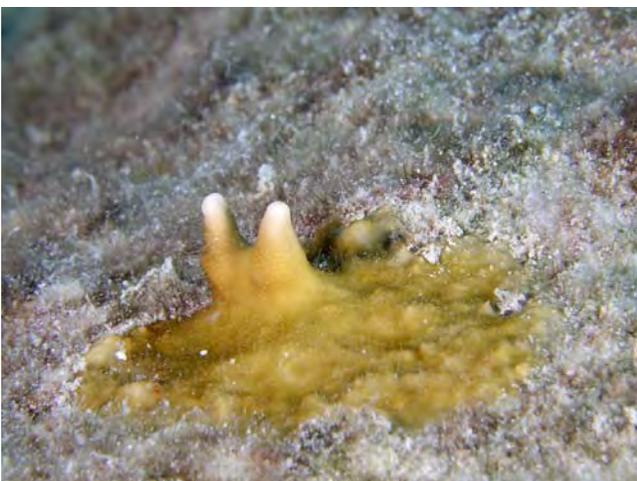
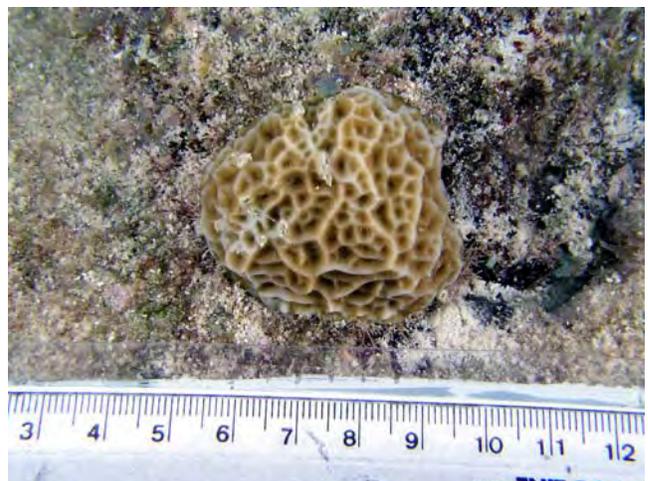
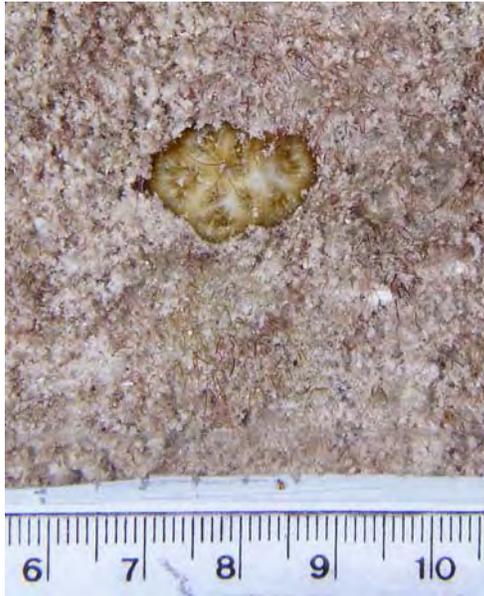
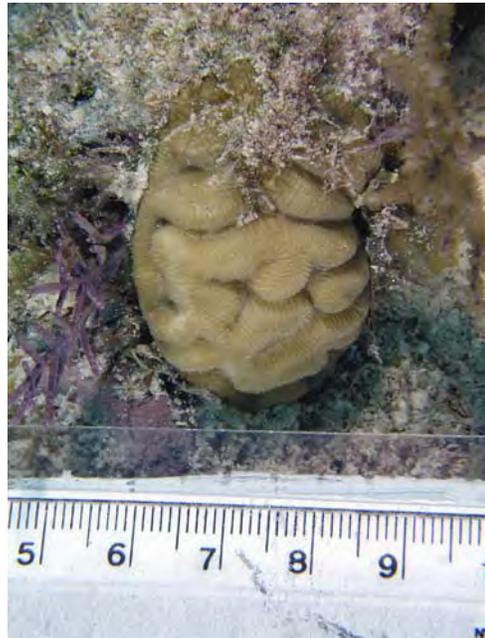
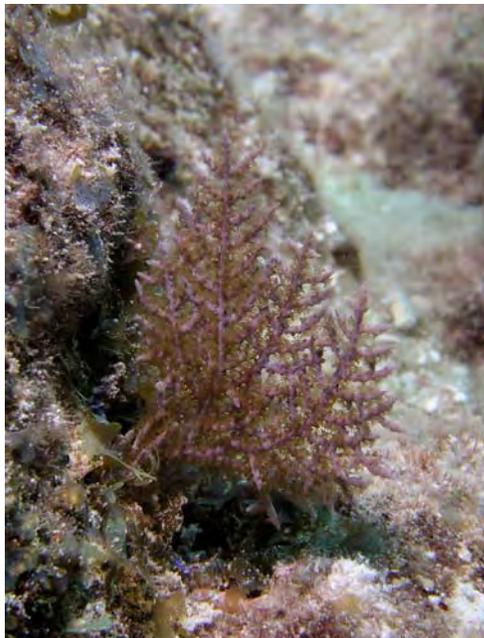
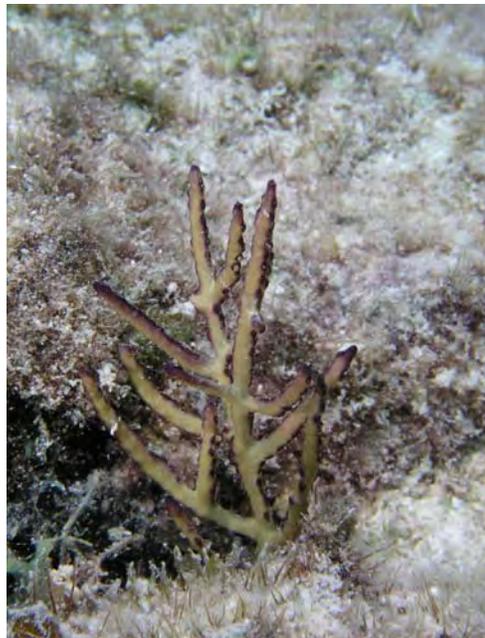
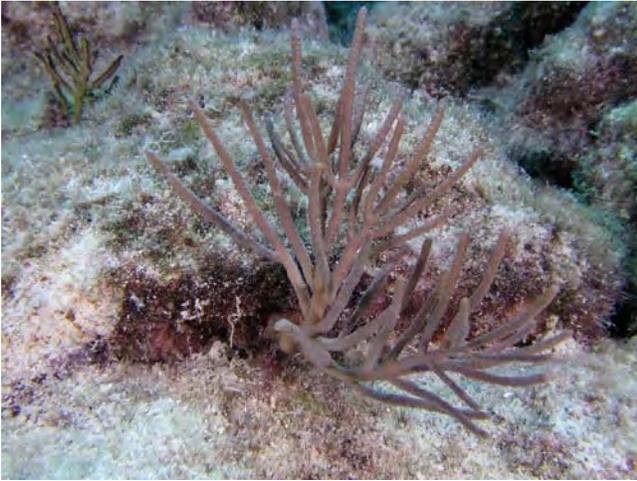
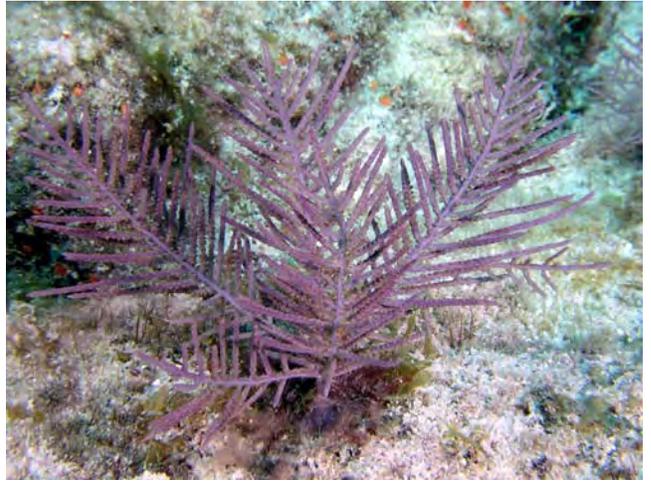
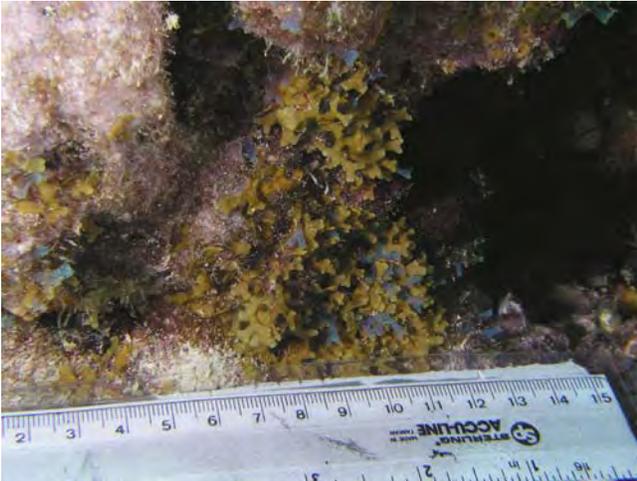
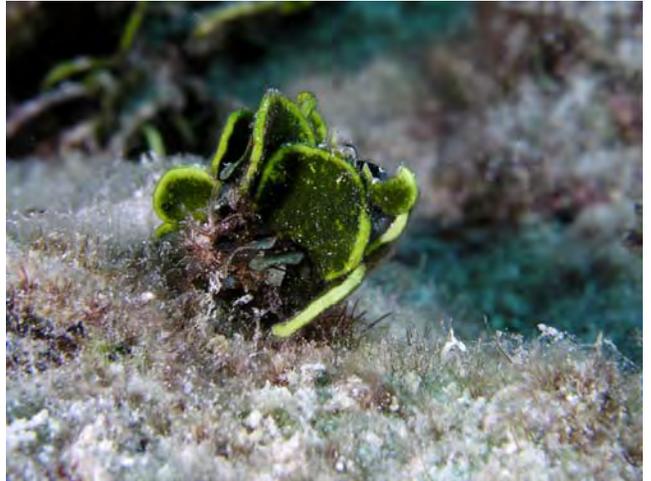
### APPENDIX 3

Photographs of benthic species surveyed on reef restoration modules during September to November 2004 monitoring event (photo credits: Jeff Anderson).
