Habitat Restoration Conducted at *ADARO* Grounding Site: Florida Keys National Marine Sanctuary

April 2004

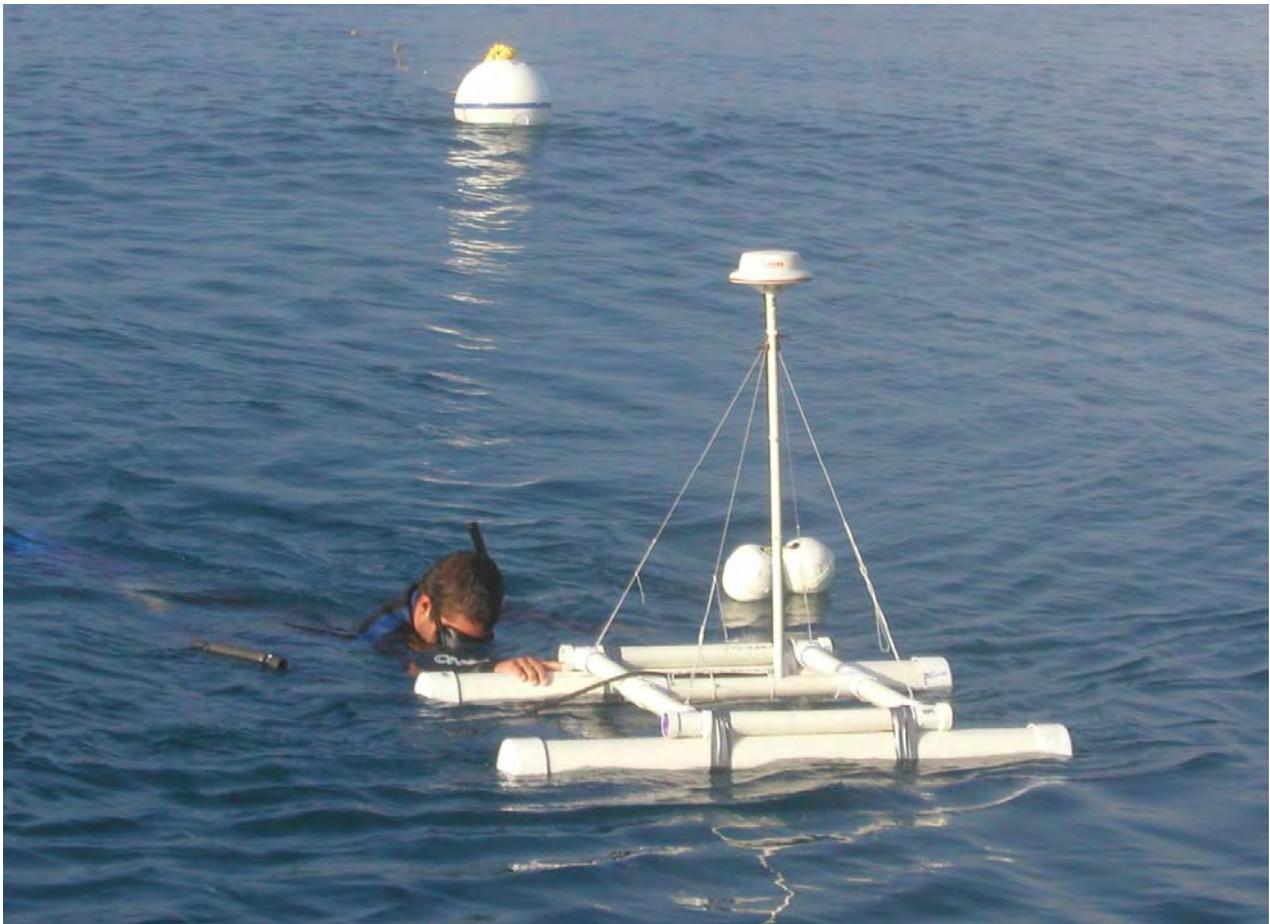
Navigational positioning data associated with high-resolution aerial photography was collected utilizing a Leica[®] MX421B DGPS with the antennae mounted on a diver-positioned catamaran (**Figure 3**). The United States Coast Guard DGPS beacon in Miami, Florida was utilized to provide positioning correctional data. The catamaran mounted DGPS antenna was tethered to the receiver with a 150-ft floating antennae cable. Deployed on-bottom markers and on-site permanent features were utilized as visual targets to provide guidance for positioning the DGPS antenna. The catamaran mounted DGPS antenna was deployed and positioned over visual targets utilizing a diver. The on-board navigator recorded navigational coordinates once the DGPS was positioned directly over the visual target.

Figure 3. Catamaran mounted DGPS antenna being positioned by a diver.

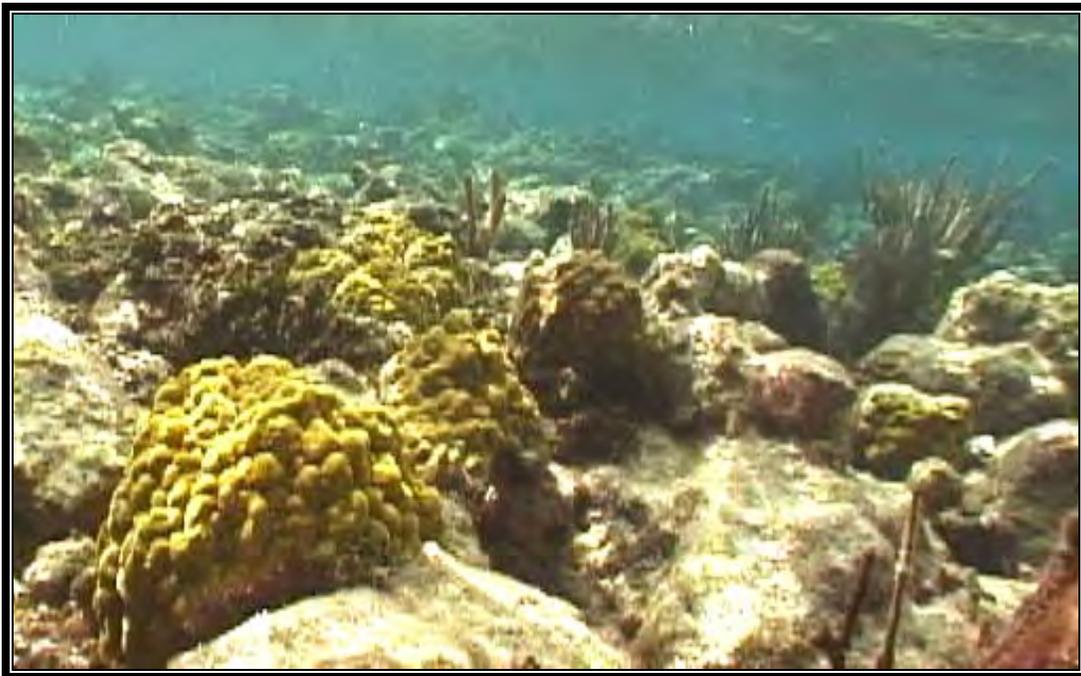
Image 2. Visually dominant epibiota associated with the impacted reef crest include the mustard-hill coral (*Porites astreoides*) shown in foreground.

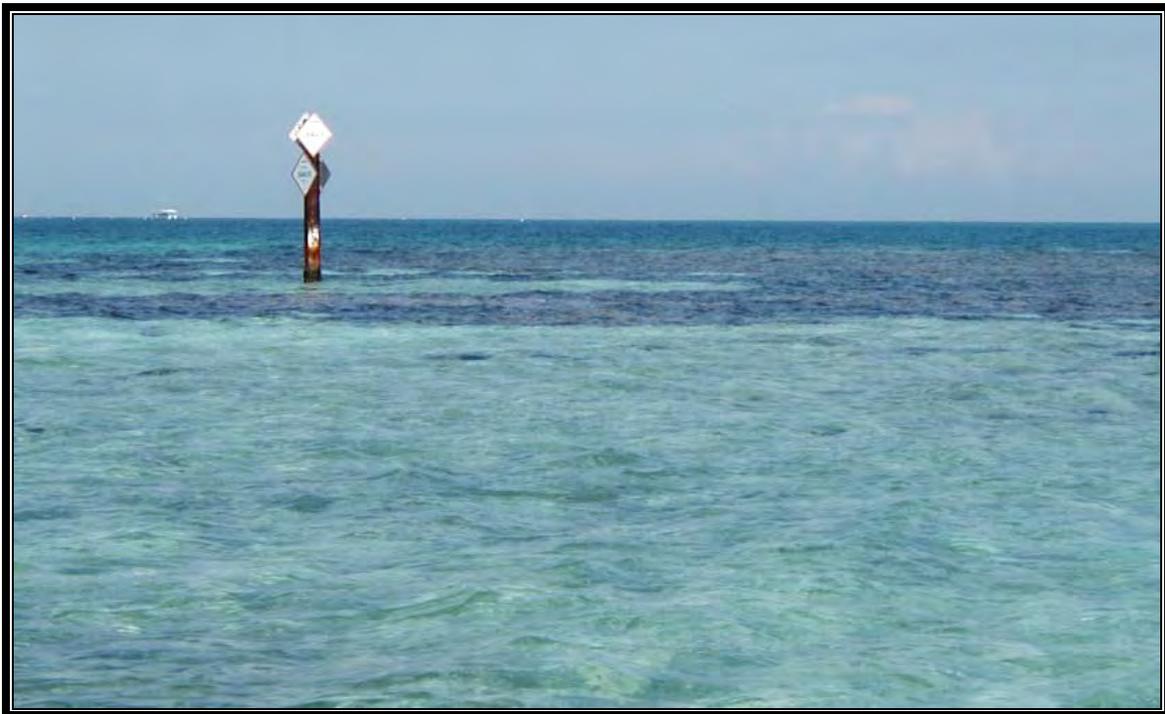
Visual targets included deployed on-bottom markers, natural permanent features of the habitat (i.e., large hard coral colonies), and permanent man-made structures (i.e., reef marker) (see **Image 4 Appendix**). Stainless steel threaded rods were permanently affixed into the substrate to anchor on-bottom markers. Measurements (i.e., distance and bearing) were collected in a south to north sequence between each of the visual targets. Navigational coordinates were collected at each of the visual targets utilizing the catamaran mounted DGPS antenna (previously described in **Vessels and Navigation**).

Image 4. Reef marker utilized as a visual target to geo-rectify aerial photographs.
